Historic Houses of West Yorkshire

Bolling Hall, Bradford

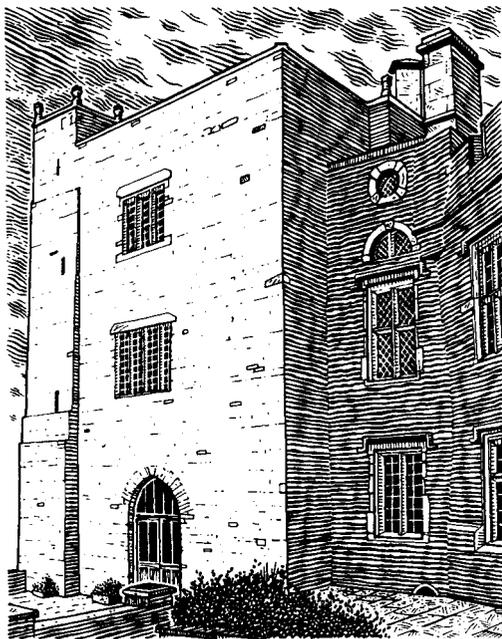
The south front of Bolling Hall, shown in the drawing above, provides the best viewpoint for understanding the growth of the house since the Middle Ages. At first glance the building has a symmetrical appearance: in the centre there is a hall with a large central window and two smaller windows positioned centrally above it; on each side there are matching doorways and matching windows above. The hall is flanked by projecting bays which, though with different kinds of windows, balance each other, and at both ends of the building the wings are fronted by three-storey towers. But this balance was, in fact, achieved only after several centuries of development; it was contrived by adding new structures to the existing group of late medieval buildings. For example, the doorway on the right-hand side of the hall leads nowhere: it backs on to a chimney stack. It is there for its visual effect, not for use.

The earliest surviving part of the Hall is the tower on the left. It was erected by the Bolling family - local landowners - in the late 14th or 15th century; though impossible to date closely, it is one of a number of towers erected at that period by northern

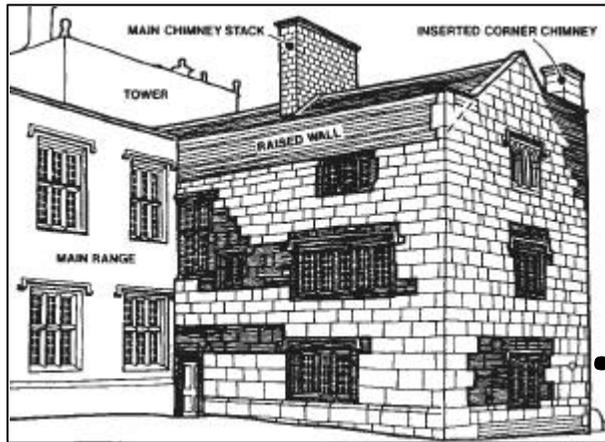
The north wall of the main range, on the left of the drawing, is obviously later than the 17th-century alterations to the wing, as it blocks part of a window. Yet the blocked window is identical in style to the main range windows, suggesting that the two phases of building activity were separated by only a short period of time. As can be seen on the plan, the main range wall fronts a series of rooms built against one side of the hall. As usual in early houses of this kind, the main range had originally been only one room wide: the north wall of the hall had been an external one. The series of rooms was added to the outside of this wall in the 17th century, but only after the two north-facing wings had been completed.

Visitors who stand in the car park, facing this side of the Hall, will see on the right a low, ruined wall containing various doorways and windows. This is all that survives of a range of outbuildings demolished sixty years ago. The doorway with pointed arch is probably medieval, but may have been moved here from some part of the Hall. During demolition this outbuilding was recorded as having elaborate timber roof trusses which had been part of a timber-framed structure; these may well have come from the late medieval timber hall which stood on the site of the present hall.

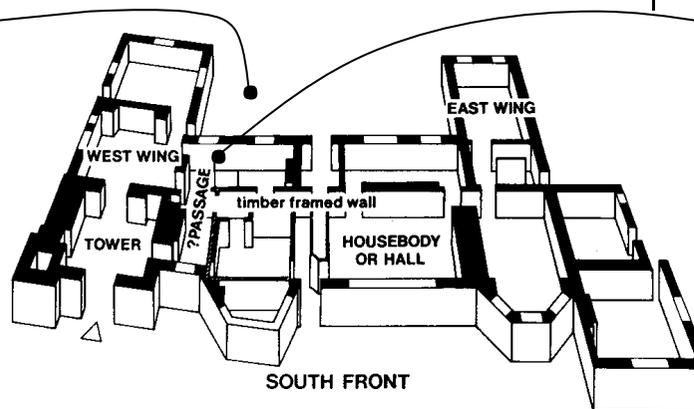
The main range itself contains fragments of this timber hall. They can be seen from the passage and staircase next to the medieval tower, and are illustrated in the drawing at the top of the right-hand column. Most of the timbering seems to be of comparatively recent date: close inspection shows that the horizontal and vertical members are not properly jointed together. But two substantial timbers are clearly from the late medieval hall. One is a 'wallplate', the piece which ran along the top of a timber-framed wall and supported the feet of the

rafters. In this case it can be seen that the angled notches, where the feet of the rafters were lodged, are on the underside of the timber; whereas pegholes show that the mortice-and-tenon joints for the wall braces are on the top. The wallplate has, therefore, been repositioned upside down. The other notable timber is a 'tie-beam', a horizontal member running across the width of the building and jointed into the wallplates at each end. This beam has patterns of mortices and pegholes which indicate the positions of timbers formerly fastened into both upper and lower surfaces. The pattern of former timbers has been reconstructed in the drawing on the

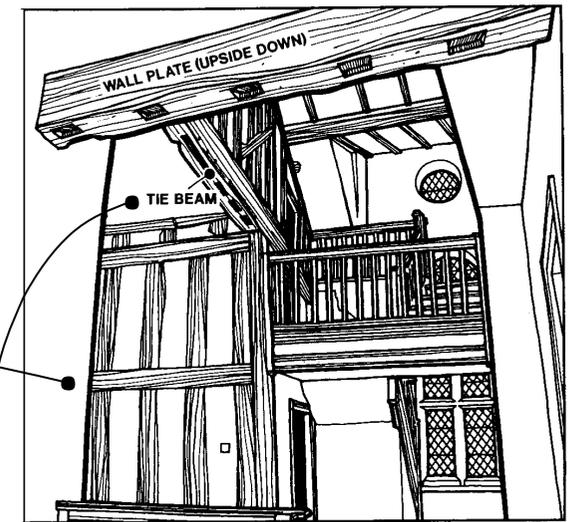
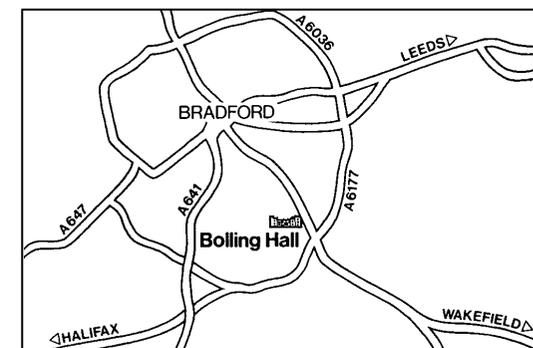
right. The closely set vertical 'studs' running downwards from the tie-beam show that this was an end wall rather than an intermediate truss; above the tie was a vertical 'king post' with four diagonals (the main rafter and three braces) on each side. The roof trusses in the demolished outbuilding are also said to have had king posts.

The style of timbering which can be seen in this reconstruction drawing suggests that the hall building was similar to that at Shibden, Halifax, and to several others erected in West Yorkshire during the 15th century.
