Historic Houses of West Yorkshire

Shibden Hall, Halifax

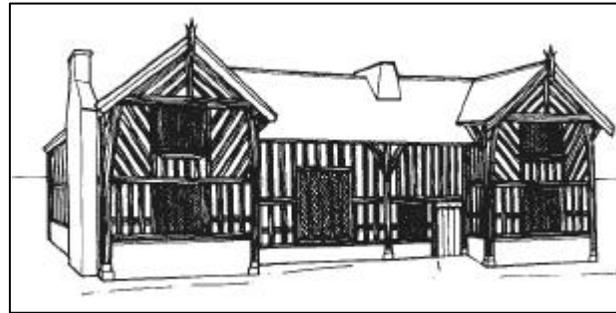
The drawing above shows the building as it may originally have appeared. The basic structure is a framework of timber, formed by a series of vertical posts (principals) and horizontal beams. The frames are filled by smaller timbers, called 'studs', set vertically, and diagonally. Between these, the rendering of clay and plaster is backed by stone slates which are slotted into the sides of the studs; the lowest horizontal beam, or sill, is supported by sandstone walling. The single-storey housebody, in the centre of the building, would have been provided with a large window to light the high table. The top of the firehood would have been seen projecting from the roof. In the two-storey wing to the left, both upper and lower chambers had fireplaces, but there was probably no heating for the rooms in the other wing, beyond the cross-passage entrance.

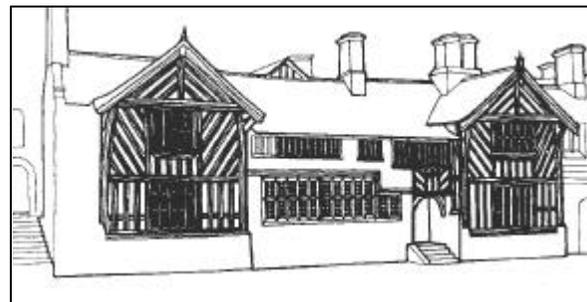
In the 16th century (below) the south wall of the housebody was taken down and brought forward a distance of about one metre. Only the principal posts,

supporting the main roof timbers, were left in position. The shift is marked by a change in roof pitch. A first-floor chamber was inserted into the housebody, lit by timber-mullioned windows just under the eaves. In the late 16th or early 17th century much of the timbering was removed and replaced by a stone wall and stone-mullioned windows. By the early 19th century most of the cross-wing timbering had also been covered over; it was revealed again during restorations in the 1830s.

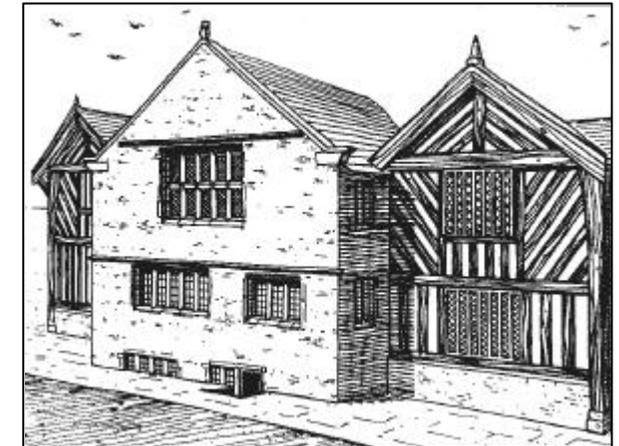
The north side of the building, shown in the drawing on

the left, was originally similar to the south side, the wings projecting on either side of the housebody. The right-hand wing probably had an external staircase giving access to the first-floor room: the upper floors of this wing are original, and show there was no internal staircase. In about 1600, however, a substantial stone building was erected directly in front of the housebody. It incorporated a new, internal staircase, and it had a cellar dairy with direct access from the yard. At the same time, or soon afterwards, rooms were added to the wing on the left; an early 19th-century painting shows that the building had mullioned windows. It was demolished and replaced in the 1830s, at the same time as a baronial-style tower was added to the other (right-hand) wing. The illustration on the cover (above right), is taken from a late 19th-century engraving. It shows the 'Norman' tower and other 19th-century additions, including a porch covering the cross-passage.

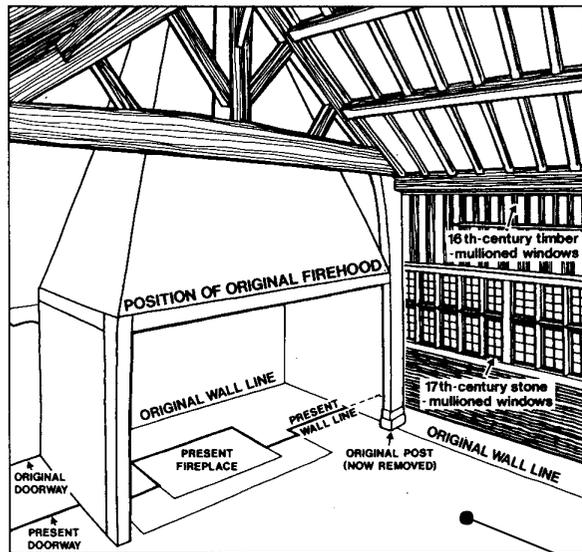
The drawing above shows the interior of the principal room of the house: the hall or 'housebody', to use a local name. It was originally open to the roof; later a floor was inserted to create a chamber over the housebody, lit by the windows just under the eaves. The chamber was removed in the 19th-century restorations; at the same time the main timbers were boxed-in, obscuring evidence which shows that the original south wall was inside the line of the present one. The position of the earliest wall-line is shown on the illustration. Also marked on the drawing is the arrangement of the earliest hearthplace. The present one belongs, again, to the 19th century, but there has been a stone fireplace and chimney in this position since, perhaps, the late 16th century. Before

then, the original hearth would have been set against the cross-passage wall. Smoke rising from it would have been carried through the roof in a timber-framed canopy, called a firehood.

The high table would have been set against the wall opposite the firehood, raised on a dais and fit by the main hall window. It may also have had a decorated timber canopy. Neither dais nor canopy survives, and the original window would have been removed when the south wall was repositioned. But the surviving timber windows may have been cut from the original ones, and some of the decorative carving on the lintels and sill-beams of the windows may have come from the dais canopy.

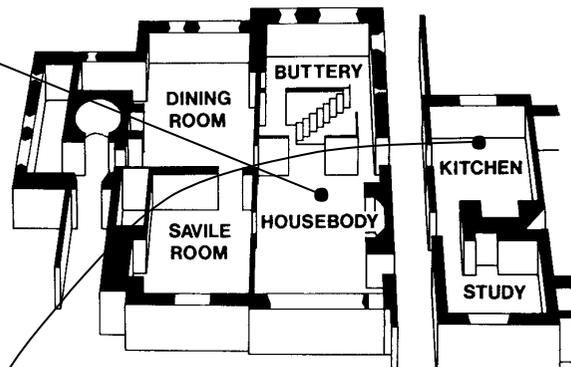
The kitchen, shown on the left, was not part of the original arrangement of facilities: the stone chimney stack, with its large arched fireplace, was inserted in the 16th century into one of the service rooms, where food had been prepared for the table, but not cooked. Either the Hall had been provided with a detached kitchen building, later demolished, or cooking had been done in the housebody itself, on the hearth beneath the firehood. The service rooms (now the kitchen and study) were originally entered from the cross-passage by two doorways with lintels carved in the shape of a double

curve (or ogee); one of these can be seen, now blocked-up, in the drawing. The two rooms were at first separated by a timber partition wall. Most of this was removed when the chimney stack was built, but a short stretch, including a doorway, survives behind the stonework. The timber beam set in the wall above the fireplace arch probably came from the same partition: it contains peg-holes for vertical timber studs. The ceiling was renewed and lifted when the room was converted into a kitchen.
